The Paddington Rail Disaster

Date: October 5th, 1999

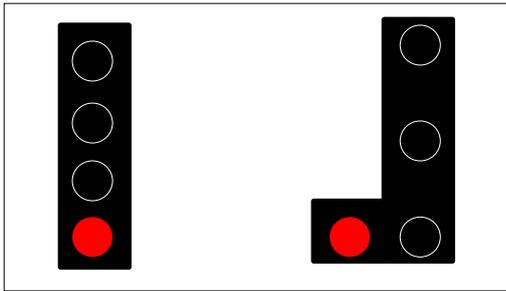
There was no failure with the on-train equipment, the AWS was working correctly and was acknowledged by the driver on the approach to signal SN109. Signal SN109 was at Ladbroke Grove. The signal was located shortly after a bridge that obstructs the sighting of the signal. Other obstructions of the signal include Overhead Line Equipment (OHLE), gantry and signage. There had been multiple SPADs at this signal since its introduction in 1993

(eight before this accident). The signal was an unconventional shape (the shape of a backwards L as opposed to the conventional shape (depicted in figure 1).

Figure 1: Conventional signal formation (left) and signal SN109 (right)

The driving data of the driver of the Thames Turbo train suggested that he was unaware of passing signal SN109 at danger. This could potentially be due to the visual clutter in the area (lineside equipment obscuring the view of the signal), the unconventional shape of the signal, the location of the sun or he could have read the incorrect signal (there were six bi-directional lines in the area). All these factors meant that the driver believed that he had a proceed aspect.

The signal has been changed to the conventional shape and is easier to see. Trains in the area are fitted with Train Protection Warning Systems (TPWS). This system stops trains when they have passed a signal at danger regardless if a driver has not recognised their error.
