Analysis of the risk from animals on the line – Issue 2

Report summary

This report provides risk and performance data relating to 'animal on the line' incidents in Great Britain. It was produced following an accident in Germany, in which a passenger was killed when a push-pull train running in 'push mode' derailed after striking a herd of cattle.

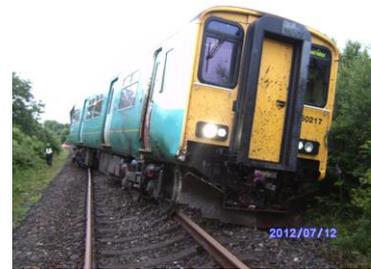
The pertinence of these lessons grew on 12 July 2012 when a passenger train struck cattle on the line and derailed at Letterston Junction (see photo).

Photo: Network Rail.

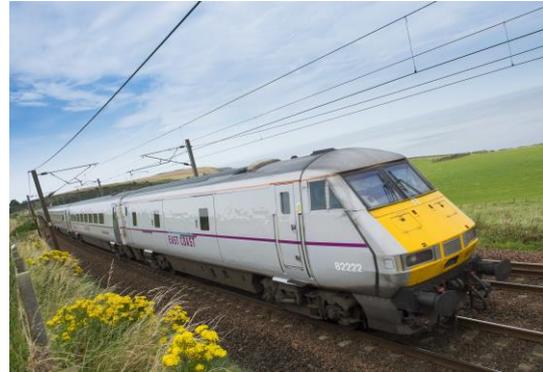
An East Coast Main Line Mark IV DVT, introduced by BR in 1988 and still in use. (See text). Photo: East Coast.
